HOME REPORT

SHEPHERD
CHARTERED SURVEYORS

2 Letham House, Mains of Letham
St. Vigean
ARBROATH
DD11 4RF
25/02/2015

Property address	Letham House 2 Mains of Letha Arbroath DD11 4RF
Customer	Mr and Mrs Chalmers
Customer address	Per Shiells Solicitors 31A Saint David Street Brechin DD9 6EG
Prepared by	J & E Shepherd
Date of inspection	19th February 2015

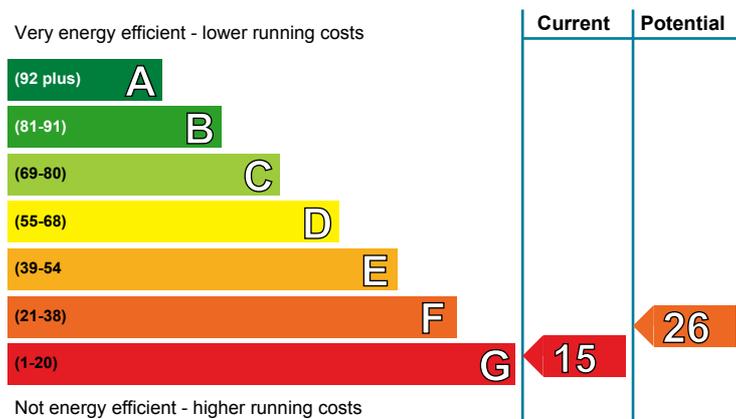
Energy Efficiency Rating

This graph shows the current efficiency of your home, taking into account both energy efficiency and fuel costs. The higher this rating, the lower your fuel bills are likely to be.

Based on calculated energy use of **594 kWh/m²/yr**, your current rating is **band G (15)**. The average rating for a home in Scotland is **band D (61)**.

The potential rating shows the effect of undertaking all of the improvement measures listed within your recommendations report.

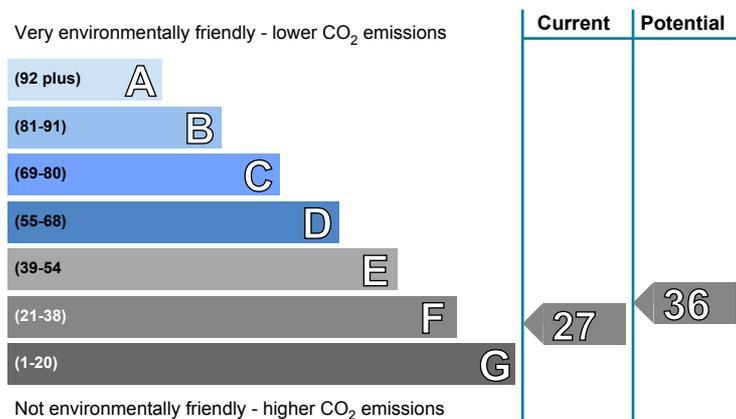
Environmental Impact (CO₂) Rating

This graph shows the effect of your home on the environment in terms of carbon dioxide (CO₂) emissions. The higher the rating, the less impact it has on the environment.
